**Space & Life Sciences Directorate
Safety & Mission Assurance Directorate**
NASA Johnson Space Center, Houston, Texas

JSC/White Sands Test Facility Safety & Health Program

Test Cell 844 Manual Valve Failure
Mishap Investigation

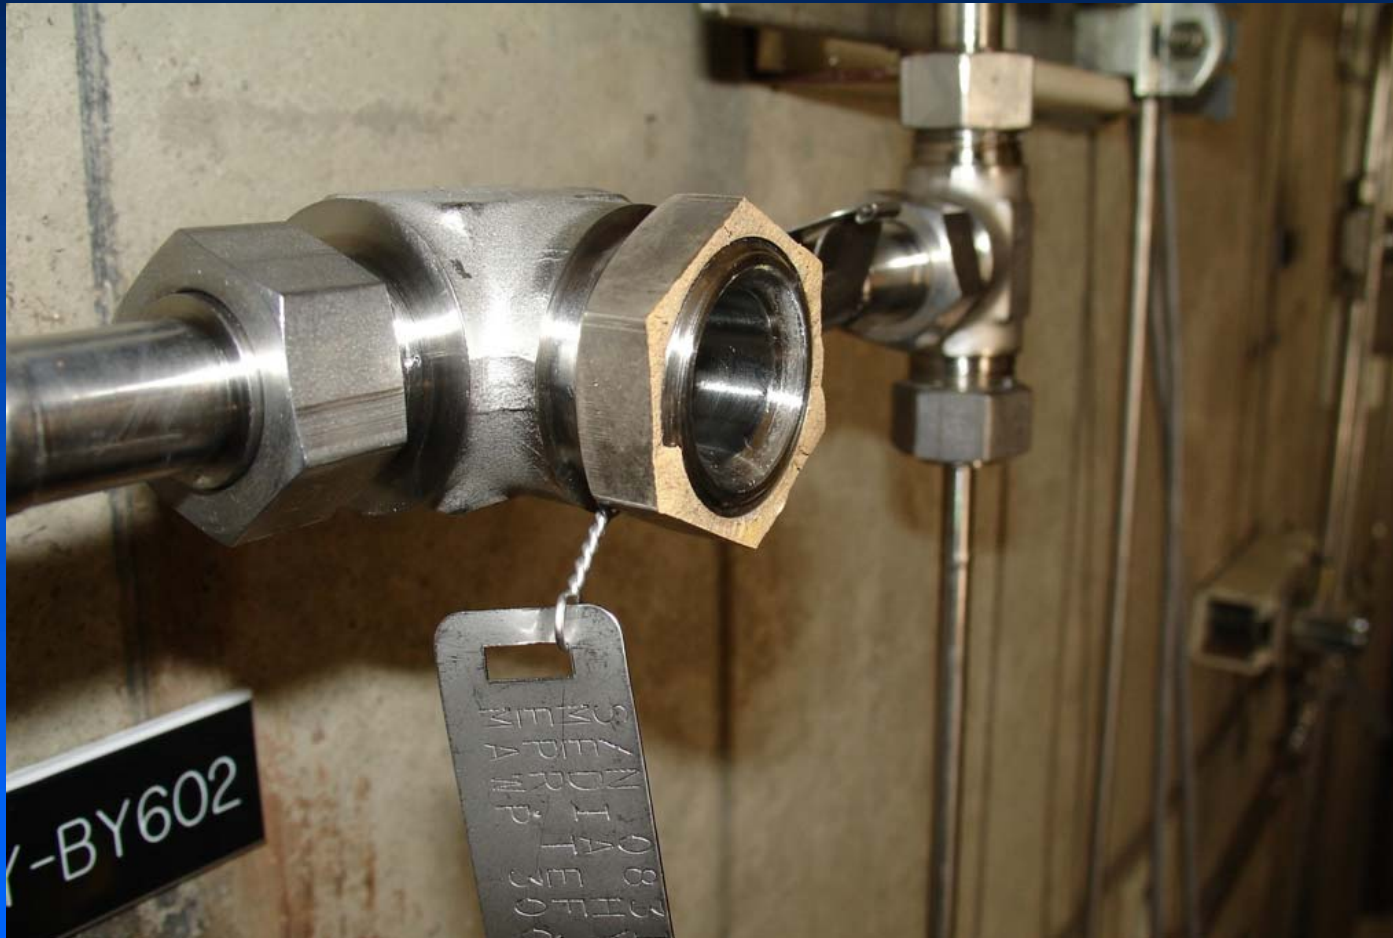
- **The failure was due to a brittle fracture of the aluminum bronze material. Environmental assisted cracking was the result of normal loading in a corrosive environment of ammonia and oxygen.**
- **Ammonia was from permeation of the seal(s) and the decomposition of hydrazine, which allowed the ammonia product to react and corrode the bonnet material (aluminum bronze).**
